Prüfbericht-Nr.: <i>Test Report No.:</i>	15104478 001	Auftrags-Nr.: <i>Order No.:</i>	154249955	Seite 1 von 6 Page 1 of 6
Kunden-Referenz-Nr.: <i>Client Reference No.:</i>	n.a	Auftragsdatum: <i>Order date:</i>	May 09, 2017	
Auftraggeber: <i>Client:</i>	Sican Co. Ltd. No.12, Lane 9, Dayou St., Luzhu Dist., Taoyuan City 33842, Taiwan, R.O.C.			
Prüfgegenstand: <i>Test item:</i>	Glass with Safety Film			
Bezeichnung / Typ-Nr.: <i>Identification / Type No.:</i>	SRC-100 (5 mm tempered glass + 0.76 mm PVB + 5mm tempered glass + 0.1 mm safety film)			
Auftrags-Inhalt: <i>Order content:</i>	Performance Test: Resistance to Hard Body Impact			
Prüfgrundlage: <i>Test specification:</i>	EN 356:2000 Glass in building - Security glazing - Testing and classification of resistance against manual attack			
Wareneingangsdatum: <i>Date of receipt:</i>	May 09, 2017	 		
Prüfmuster-Nr.: <i>Test sample No.:</i>	20170626-03

Produktbeschreibung
Product description

1	Produktdetails <i>Product details</i>	Glass with safety film
2	Maße <i>Dimensions</i>	1100 mm (Length) × 900 mm (Width) Thickness: 5 mm tempered glass + 0.76 mm PVB + 5mm tempered glass + 0.1 mm safety film
3	Bedienelemente <i>Operating eleme

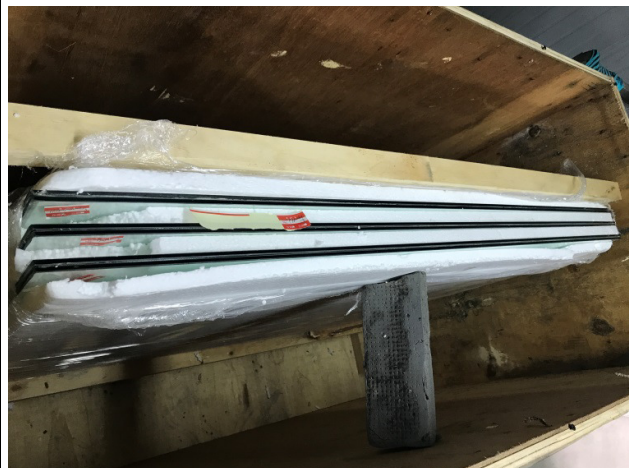
Sample received

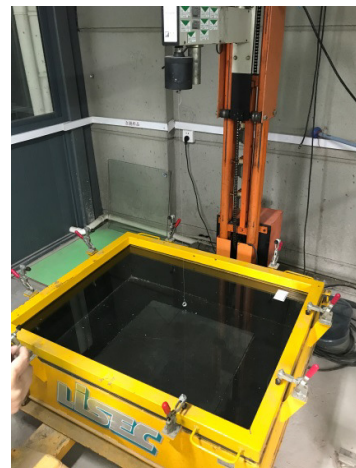
Sample in the test equipment

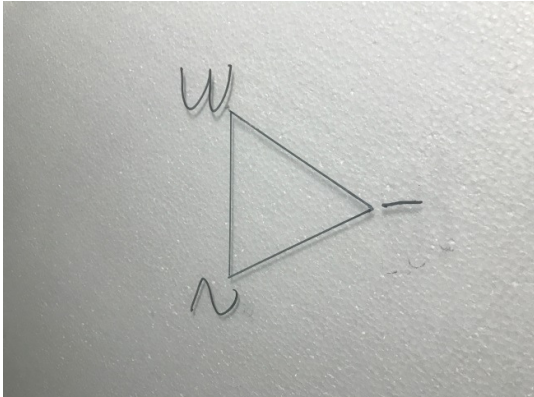
Impact positions on each sample

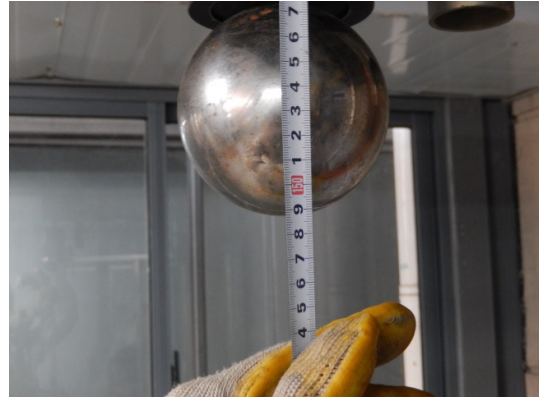
Measure the drop height

Impactor (hard body): steel sphere with a diameter of (100±0.2) mm and a mass of (4.11±0.06) kg.
Drop height: (1500 ± 50) mm
Category of resistance: P1A

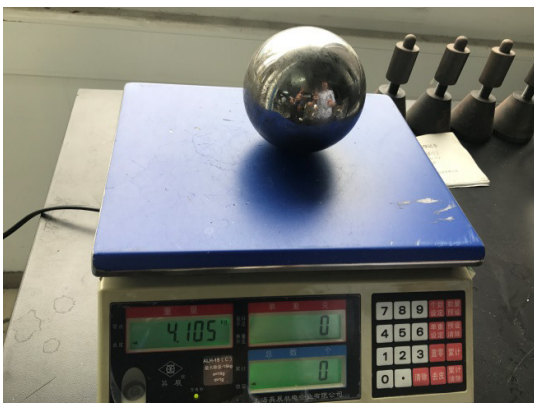
Mass of the impactor: 4.10 kg

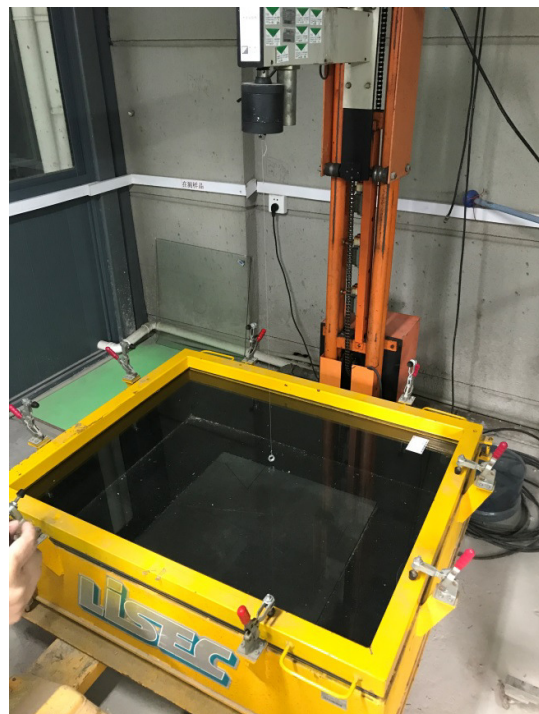
Test equipment with sample

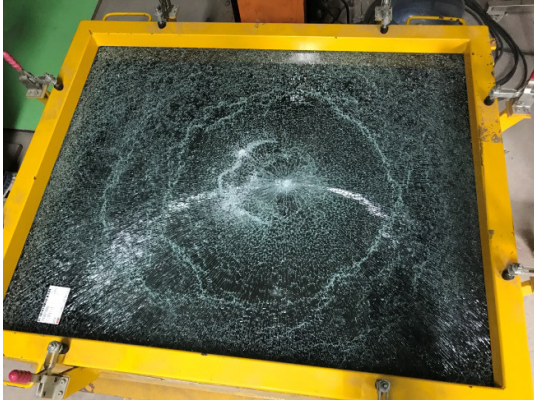
After impact of No.1 sample

Sample No.	Result after first impact	Result after second impact	Result after third impact
1	Glass broke, the impactor didn't pass through the sample in 5 seconds.	Glass broke, the impactor didn't pass through the sample in 5 seconds.	Glass broke, the impactor didn't pass through the sample in 5 seconds.
2	Glass didn't break.	Glass didn't break.	Glass broke, the impactor didn't pass through the sample in 5 seconds.
3	Glass didn't break.	Glass broke, the impactor didn't pass through the sample in 5 seconds.	Glass broke, the impactor didn't pass through the sample in 5 seconds.

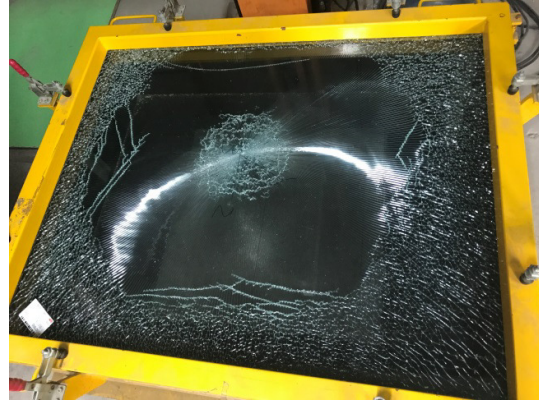
After impact of No.2 sample

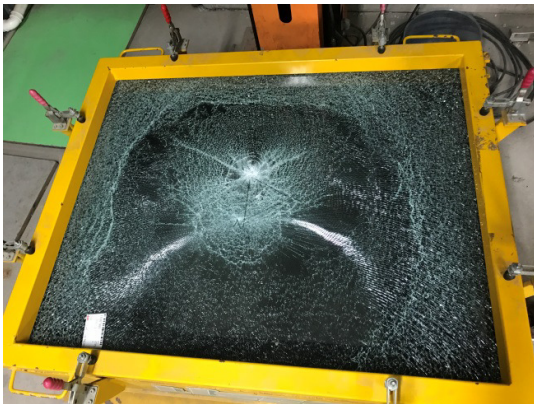
After impact of No.3 sample

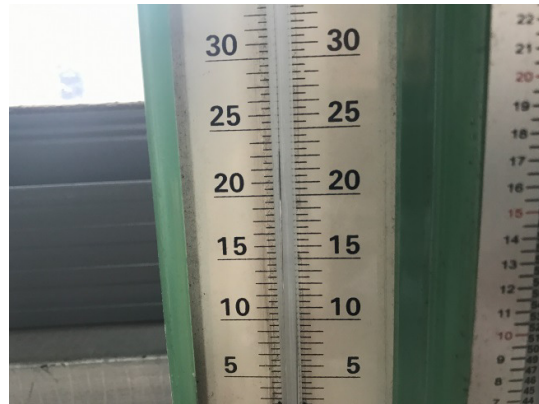
Test temperature: 23.5 °C

Test Standard	EN 356:2000, clause 8
Requirement	EN 356:2000, clause 7.1
Test Environment	23.5 °C Note: Required temperature in the standard: (23±2) °C
